TENNESSEE RESIDENTIAL PROPERTY CONDITION DISCLOSURE

7942 HAMILTON MILL DRIVE CHATTANOOGA, TENNESSEE 37421-2761 CLAIM NUMBER: HP0001483425

DONAN PROJECT NUMBER: 12-12080810-0

DONAN ENGINEERING CO., INC.

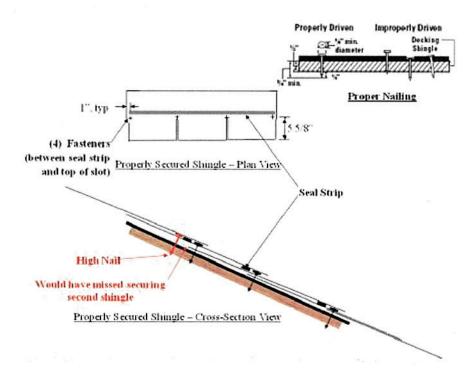
Figure 1: Proper Fastener Installation

Roofing fasteners were observed to have been improperly installed throughout the roof. Industry practice for conventional three-tab asphalt or dimensional shingles nailed on slopes ranging up to 21/12 pitch calls for four nails to be installed per shingle where no other adverse conditions such as expected high winds apply (Figure 1).

All shingles should receive no less than four nails, one at each end and one over each interior cutout (keyway). The nails should be located approximately $5^5/_8$ inches above the bottom of the shingle, above the upper shingle cover and below the self seal strip for three tab shingles or on the nail line provided by the manufacturer for dimensional shingles. Nails installed below this line are exposed on the roof to the elements and become potential leak sources, and nails through the sealant strip or above the sealant strip (or nail line for dimensional shingles) either undermine its adhesive potential or greatly reduce the shingle's overall
